**TITLE: ROOF CONDITION REPORT**

THE SCOPE OF THE SERVICES PERTAINED IN THIS DOCUMENT IS A DETAILED ASSESSMENT FOR THE ROOF CONDITION OF THE INDUSTRIAL BUILDING WITHIN THE SITE BOUNDARY TO ASCERTAIN SUITABILITY IN RELATION OF INSTALLATION OF PV PANELS.

THIS REPORT CONTAINS COMMENTARY AND HIGHLIGHTS ON ANY DEFECTS INSPECTED VISUALLY VIA DRONE. A DRONE SURVEY FOR THE SITE HAS BEEN CARRIED OUT AND A FULL SITE AERIAL RECONNAISSANCE HAS TAKEN PLACE WHICH FORMS THE BASIS OF THIS REPORT.

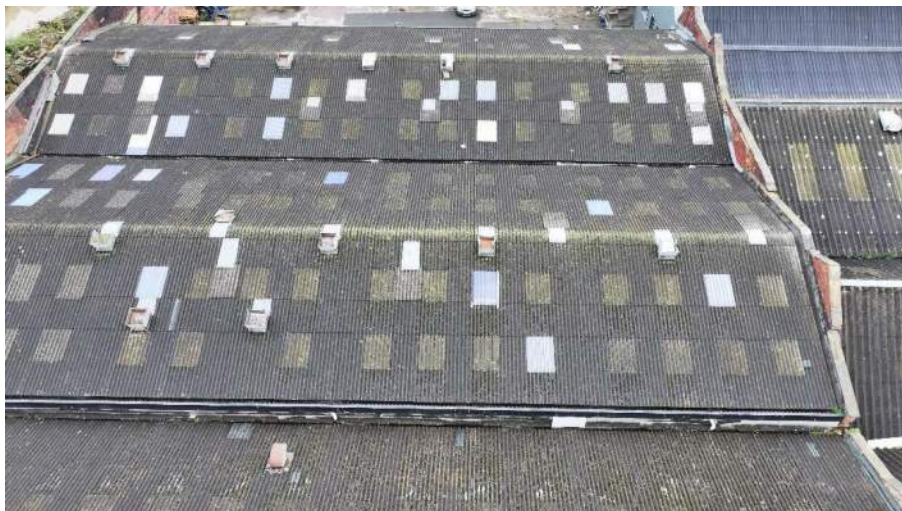
*FIGURE 2: AERIAL PERSPECTIVE OF ROOF 2*

THE MAIN ROOF COVERING APPEARS TO BE IN FAIR CONDITION WITH DEFECTS NOTED AS BELOW:

- FLASHING AGAINST GABLE IS DAMAGED AND LOOSE ON ROOF.
- GENERAL STAINING THROUGHOUT THE ROOF AND VEGETATION GROWTH IN TROUGHS OF ROOF SHEETING.
- GRP ROOF LIGHTS HAVE BEEN REPAIRED INDICATING PREVIOUS FAILURE/ DAMAGE EXISTING ROOF LIGHTS MAY REQUIRE REMEDIATION IN THE FUTURE.
- GUTTERS ARE OBSTRUCTED WITH DEBRIS AND VEGETATION.
- WEATHER DEGRADATION HAS BEEN OBSERVED THROUGHOUT.
- LOOSE/ MISSING BRICKS ARE FOUND AT THE BRICK WORK TO THE GABLE PARAPET.
- GENERAL DEBRIS ON ROOF INCLUDING WOODEN PLANKS ETC.

- THE FIBRE CEMENT SHEETS ARE TO REMAIN INTACT AND NO INTRUSIVE WORK IS TO BE CARRIED OUT BY PERSONNEL ON SITE OTHER THAN AS SPECIFIED BY MOUNTING DESIGNER. MOUNTING DESIGN SHOULD BE PRESENTED TO STRUCTURAL ENGINEER FOR APPROVAL BEFORE BEING IMPLEMENTED.
- WEATHERED SHEETS ARE PERFORMING ADEQUATELY AND NO SIGNIFICANT DEFECTS IN PERFORMANCE HAVE BEEN FOUND. NO SIGNIFICANT DEFLECTIONS HAVE BEEN NOTED THROUGHOUT ANY OF THE BUILDING ROOF FABRIC.
- VEGETATION GROWTH IS TO BE TREATED AND REMOVED THROUGHOUT AS THIS IS LIKELY TO CAUSE SIGNIFICANT PERFORMANCE ISSUES AND WILL LEAD TO EXPENSIVE REPLACEMENT OF SHEETS IN THE LONG TERM. CLEANING USING A SOFT-BRISTLE BRUSH OR SPONGE, APPLY THE CLEANER TO THE CLADDING SURFACE, WORKING IN SMALL SECTIONS FROM TOP TO BOTTOM. WASHING OF PANELS TO BE UNDERTAKING BY A SPECIALIST ROOF CLEANING COMPANY.

- RAIN WATER GOODS, APEX FLASHINGS AND OTHER METAL FLASHINGS SHOW SIGNS OF DAMAGE. REPLACEMENT OF THESE ARE BEST PRACTICE FOR THE PROLONGED LIFE OF THE ROOF ANY DAMAGED FLASHING MUST BE REPLACED.
- ALL FIXINGS TO SHEETS ETC TO BE FULLY INSPECTED AND REPLACED WHERE ANY DEFECT/CORROSION IS OBSERVED AT THE TIME OF PV INSTALLATION. HOWEVER, NO SIGNIFICANT DEFECT TO FIXINGS HAVE BEEN OBSERVED AT PRESENT.
- GENERAL DEBRIS ON ROOF SHOULD BE REMOVED SUCH AS LARGE ITEMS E.G. PLANKS ETC HAVE BEEN OBSERVED THESE GATHER WATER AND OTHER VEGETATIVE MATER OVER TIME AND HAVE A DETRIMENTAL EFFECT ON THE ROOF.
- LOOSE/ MISSING BRICKS SHOULD BE REPLACED LIKE FOR LIKE.

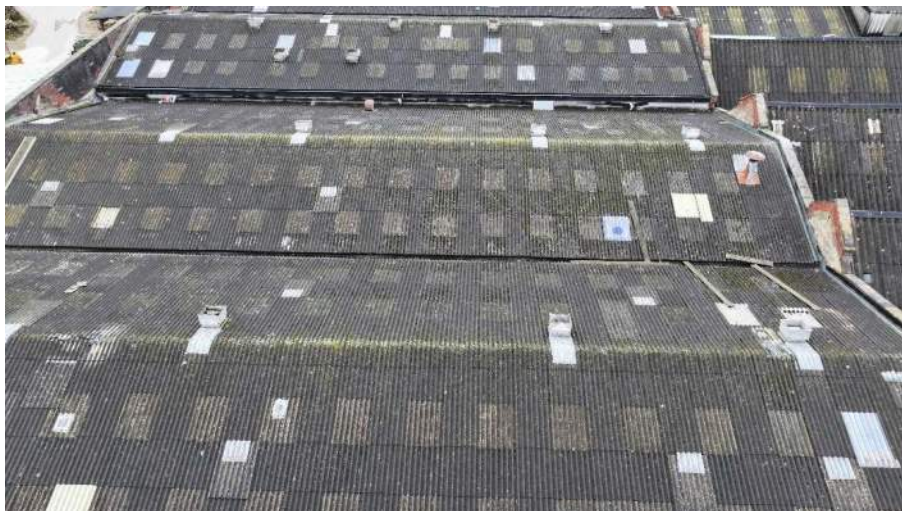
*FIGURE 3: AERIAL PERSPECTIVE OF ROOF 3*

THE MAIN ROOF COVERING APPEARS TO BE IN FAIR CONDITION WITH DEFECTS NOTED AS BELOW:

- FLASHING AGAINST GABLE IS DAMAGED AND LOOSE ON ROOF.
- GENERAL STAINING THROUGHOUT THE ROOF AND VEGETATION GROWTH IN TROUGHS OF ROOF SHEETING.
- GRP ROOF LIGHTS HAVE BEEN REPAIRED INDICATING PREVIOUS FAILURE/ DAMAGE EXISTING ROOF LIGHTS MAY REQUIRE REMEDIATION IN THE FUTURE.
- GUTTERS ARE OBSTRUCTED WITH DEBRIS AND VEGETATION.
- WEATHER DEGRADATION HAS BEEN OBSERVED THROUGHOUT.
- LOOSE/ MISSING BRICKS ARE FOUND AT THE BRICK WORK TO THE GABLE PARAPET.
- GENERAL DEBRIS ON ROOF INCLUDING WOODEN PLANKS ETC.
- CHIMNEY SHOWS SIGNS OF CORROSION WHICH MAY LEAD TO FURTHER DETERIORATION.

- THE FIBRE CEMENT SHEETS ARE TO REMAIN INTACT AND NO INTRUSIVE WORK IS TO BE CARRIED OUT BY PERSONNEL ON SITE OTHER THAN AS SPECIFIED BY MOUNTING DESIGNER. MOUNTING DESIGN SHOULD BE PRESENTED TO STRUCTURAL ENGINEER FOR APPROVAL BEFORE BEING IMPLEMENTED.
- WEATHERED SHEETS ARE PERFORMING ADEQUATELY AND NO SIGNIFICANT DEFECTS IN PERFORMANCE HAVE BEEN FOUND. NO SIGNIFICANT DEFLECTIONS HAVE BEEN NOTED THROUGHOUT ANY OF THE BUILDING ROOF FABRIC.
- VEGETATION GROWTH IS TO BE TREATED AND REMOVED THROUGHOUT AS THIS IS LIKELY TO CAUSE SIGNIFICANT PERFORMANCE ISSUES AND WILL LEAD TO EXPENSIVE REPLACEMENT OF SHEETS IN THE LONG TERM. CLEANING USING A SOFT-BRISTLE BRUSH OR SPONGE, APPLY THE CLEANER TO THE CLADDING SURFACE, WORKING IN SMALL SECTIONS FROM TOP TO BOTTOM. WASHING OF PANELS TO BE UNDERTAKING BY A SPECIALIST ROOF CLEANING COMPANY.

- RAIN WATER GOODS, APEX FLASHINGS AND OTHER METAL FLASHINGS SHOW SIGNS OF DAMAGE. REPLACEMENT OF THESE ARE BEST PRACTICE FOR THE PROLONGED LIFE OF THE ROOF ANY DAMAGED FLASHING MUST BE REPLACED.
- ALL FIXINGS TO SHEETS ETC TO BE FULLY INSPECTED AND REPLACED WHERE ANY DEFECT/CORROSION IS OBSERVED AT THE TIME OF PV INSTALLATION. HOWEVER, NO SIGNIFICANT DEFECT TO FIXINGS HAVE BEEN OBSERVED AT PRESENT.
- GENERAL DEBRIS ON ROOF SHOULD BE REMOVED SUCH AS LARGE ITEMS E.G. PLANKS ETC HAVE BEEN OBSERVED THESE GATHER WATER AND OTHER VEGETATIVE MATER OVER TIME AND HAVE A DETRIMENTAL EFFECT ON THE ROOF.
- LOOSE/ MISSING BRICKS SHOULD BE REPLACED LIKE FOR LIKE.
- CHIMNEY SHOULD BE INSPECTED AND REPLACED IF REQUIRED.

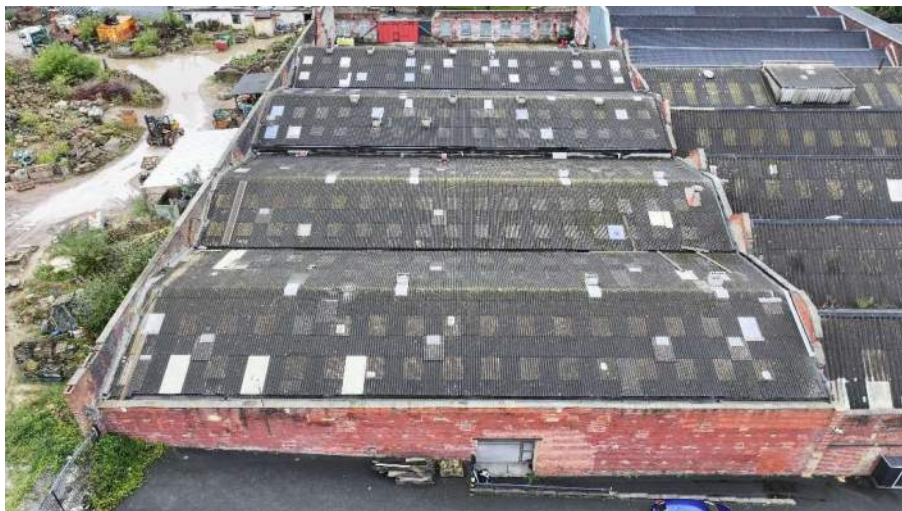
*FIGURE 4: AERIAL PERSPECTIVE OF ROOF 4*

THE MAIN ROOF COVERING APPEARS TO BE IN FAIR CONDITION WITH DEFECTS NOTED AS BELOW:

- FLASHING AGAINST GABLE IS DAMAGED AND LOOSE ON ROOF.
- GENERAL STAINING THROUGHOUT THE ROOF AND VEGETATION GROWTH IN TROUGHS OF ROOF SHEETING.
- GRP ROOF LIGHTS HAVE BEEN REPAIRED INDICATING PREVIOUS FAILURE/ DAMAGE EXISTING ROOF LIGHTS MAY REQUIRE REMEDIATION IN THE FUTURE.
- GUTTERS ARE OBSTRUCTED WITH DEBRIS AND VEGETATION.
- WEATHER DEGRADATION HAS BEEN OBSERVED THROUGHOUT.
- LOOSE/ MISSING BRICKS ARE FOUND AT THE BRICK WORK TO THE GABLE PARAPET.
- LOOSE/ MISSING COPE STONES ARE FOUND AT THE GABLE PARAPET EDGE.
- GENERAL DEBRIS ON ROOF INCLUDING WOODEN PLANKS ETC.

- THE FIBRE CEMENT SHEETS ARE TO REMAIN INTACT AND NO INTRUSIVE WORK IS TO BE CARRIED OUT BY PERSONNEL ON SITE OTHER THAN AS SPECIFIED BY MOUNTING DESIGNER. MOUNTING DESIGN SHOULD BE PRESENTED TO STRUCTURAL ENGINEER FOR APPROVAL BEFORE BEING IMPLEMENTED.
- WEATHERED SHEETS ARE PERFORMING ADEQUATELY AND NO SIGNIFICANT DEFECTS IN PERFORMANCE HAVE BEEN FOUND. NO SIGNIFICANT DEFLECTIONS HAVE BEEN NOTED THROUGHOUT ANY OF THE BUILDING ROOF FABRIC.
- VEGETATION GROWTH IS TO BE TREATED AND REMOVED THROUGHOUT AS THIS IS LIKELY TO CAUSE SIGNIFICANT PERFORMANCE ISSUES AND WILL LEAD TO EXPENSIVE REPLACEMENT OF SHEETS IN THE LONG TERM. CLEANING USING A SOFT-BRISTLE BRUSH OR SPONGE, APPLY THE CLEANER TO THE CLADDING SURFACE, WORKING IN SMALL SECTIONS FROM TOP TO BOTTOM. WASHING OF PANELS TO BE UNDERTAKING BY A SPECIALIST ROOF CLEANING COMPANY.

- RAIN WATER GOODS, APEX FLASHINGS AND OTHER METAL FLASHINGS SHOW SIGNS OF DAMAGE. REPLACEMENT OF THESE ARE BEST PRACTICE FOR THE PROLONGED LIFE OF THE ROOF ANY DAMAGED FLASHING MUST BE REPLACED.
- ALL FIXINGS TO SHEETS ETC TO BE FULLY INSPECTED AND REPLACED WHERE ANY DEFECT/CORROSION IS OBSERVED AT THE TIME OF PV INSTALLATION. HOWEVER, NO SIGNIFICANT DEFECT TO FIXINGS HAVE BEEN OBSERVED AT PRESENT.
- GENERAL DEBRIS ON ROOF SHOULD BE REMOVED SUCH AS LARGE ITEMS E.G. PLANKS ETC HAVE BEEN OBSERVED THESE GATHER WATER AND OTHER VEGETATIVE MATER OVER TIME AND HAVE A DETRIMENTAL EFFECT ON THE ROOF.
- LOOSE/ MISSING BRICKS SHOULD BE REPLACED LIKE FOR LIKE.
- LOOSE/ MISSING COPESTONE SHOULD BE REPLACED LIKE FOR LIKE.

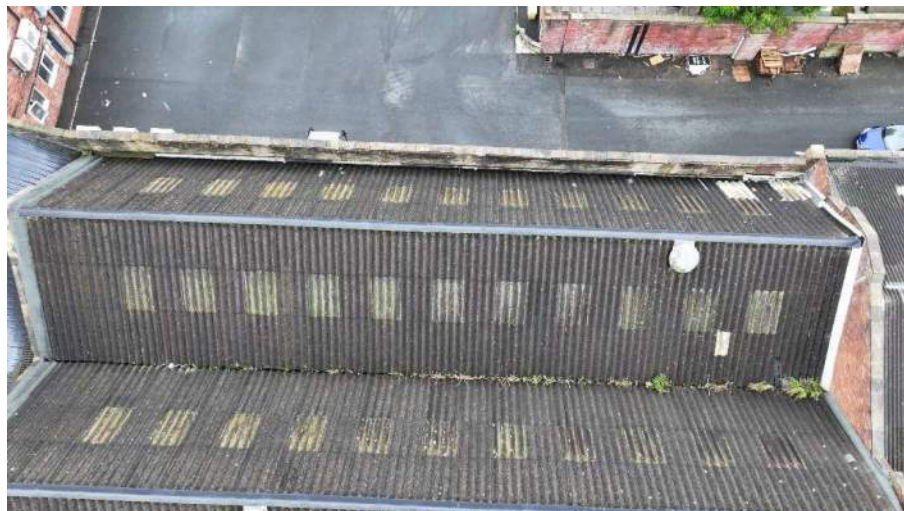
*FIGURE 5: AERIAL PERSPECTIVE OF ROOF 5*

THE MAIN ROOF COVERING APPEARS TO BE IN FAIR CONDITION WITH DEFECTS NOTED AS BELOW:

- FLASHING AGAINST GABLE IS DAMAGED AND LOOSE ON ROOF.
- GENERAL STAINING THROUGHOUT THE ROOF AND VEGETATION GROWTH IN TROUGHS OF ROOF SHEETING.
- GRP ROOF LIGHTS HAVE BEEN REPAIRED INDICATING PREVIOUS FAILURE/ DAMAGE EXISTING ROOF LIGHTS MAY REQUIRE REMEDIATION IN THE FUTURE.
- GUTTERS ARE OBSTRUCTED WITH DEBRIS AND VEGETATION.
- WEATHER DEGRADATION HAS BEEN OBSERVED THROUGHOUT.
- GENERAL DEBRIS ON ROOF INCLUDING BROKEN PIECES FOR RAIN WATER GOODS.

- WEATHERED SHEETS ARE PERFORMING ADEQUATELY AND NO SIGNIFICANT DEFECTS IN PERFORMANCE HAVE BEEN FOUND. NO SIGNIFICANT DEFLECTIONS HAVE BEEN NOTED THROUGHOUT ANY OF THE BUILDING ROOF FABRIC.

- VEGETATION GROWTH IS TO BE TREATED AND REMOVED THROUGHOUT AS THIS IS LIKELY TO CAUSE SIGNIFICANT PERFORMANCE ISSUES AND WILL LEAD TO EXPENSIVE REPLACEMENT OF SHEETS IN THE LONG TERM. CLEANING USING A SOFT-BRISTLE BRUSH OR SPONGE, APPLY THE CLEANER TO THE CLADDING SURFACE, WORKING IN SMALL SECTIONS FROM TOP TO BOTTOM. WASHING OF PANELS TO BE UNDERTAKING BY A SPECIALIST ROOF CLEANING COMPANY.

- RAIN WATER GOODS, APEX FLASHINGS AND OTHER METAL FLASHINGS SHOW SIGNS OF DAMAGE. REPLACEMENT OF THESE ARE BEST PRACTICE FOR THE PROLONGED LIFE OF THE ROOF ANY DAMAGED FLASHING MUST BE REPLACED.

- ALL FIXINGS TO SHEETS ETC TO BE FULLY INSPECTED AND REPLACED WHERE ANY DEFECT/CORROSION IS OBSERVED AT THE TIME OF PV INSTALLATION. HOWEVER, NO SIGNIFICANT DEFECT TO FIXINGS HAVE BEEN OBSERVED AT PRESENT.
- GENERAL DEBRIS ON ROOF SHOULD BE REMOVED.
- A TIMBER ROT AND INFESTATION SURVEY BY A SPECIALIST CONTRACTOR SHOULD BE UNDERTAKEN TO THE TIMBER STRUCTURE BEFORE ANY WORKS ARE CARRIED OUT TO ENSURE COMPLIANCE WITH THE 25YEAR LIFE SPAN OF THE PV PROJECT.

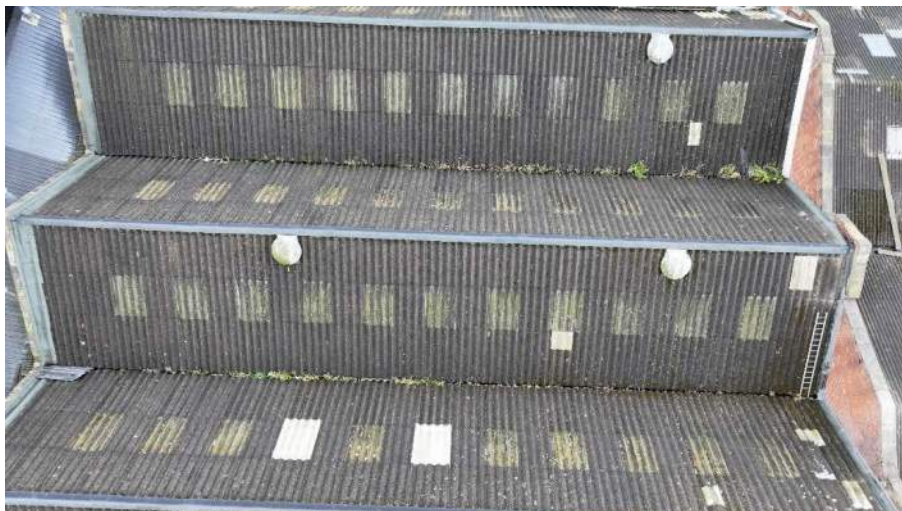
*FIGURE 6: AERIAL PERSPECTIVE OF ROOF 6*

THE MAIN ROOF COVERING APPEARS TO BE IN FAIR CONDITION WITH DEFECTS NOTED AS BELOW:

- FLASHING AGAINST GABLE HAS BEEN PATCHED UP SHOWING PREVIOUS DAMAGE.
- GENERAL STAINING THROUGHOUT THE ROOF AND VEGETATION GROWTH IN TROUGHS OF ROOF SHEETING.
- GRP ROOF LIGHTS HAVE BEEN REPAIRED INDICATING PREVIOUS FAILURE/ DAMAGE EXISTING ROOF LIGHTS MAY REQUIRE REMEDIATION IN THE FUTURE.
- GUTTERS ARE OBSTRUCTED WITH DEBRIS AND VEGETATION.
- WEATHER DEGRADATION HAS BEEN OBSERVED THROUGHOUT.
- ACCESS LADDER ON ROOF.

- WEATHERED SHEETS ARE PERFORMING ADEQUATELY AND NO SIGNIFICANT DEFECTS IN PERFORMANCE HAVE BEEN FOUND. NO SIGNIFICANT DEFLECTIONS HAVE BEEN NOTED THROUGHOUT ANY OF THE BUILDING ROOF FABRIC.

- VEGETATION GROWTH IS TO BE TREATED AND REMOVED THROUGHOUT AS THIS IS LIKELY TO CAUSE SIGNIFICANT PERFORMANCE ISSUES AND WILL LEAD TO EXPENSIVE REPLACEMENT OF SHEETS IN THE LONG TERM. CLEANING USING A SOFT-BRISTLE BRUSH OR SPONGE, APPLY THE CLEANER TO THE CLADDING SURFACE, WORKING IN SMALL SECTIONS FROM TOP TO BOTTOM. WASHING OF PANELS TO BE UNDERTAKING BY A SPECIALIST ROOF CLEANING COMPANY.

- RAIN WATER GOODS, APEX FLASHINGS AND OTHER METAL FLASHINGS SHOW SIGNS OF DAMAGE. REPLACEMENT OF THESE ARE BEST PRACTICE FOR THE PROLONGED LIFE OF THE ROOF ANY DAMAGED FLASHING MUST BE REPLACED.

- ALL FIXINGS TO SHEETS ETC TO BE FULLY INSPECTED AND REPLACED WHERE ANY DEFECT/CORROSION IS OBSERVED AT THE TIME OF PV INSTALLATION. HOWEVER, NO SIGNIFICANT DEFECT TO FIXINGS HAVE BEEN OBSERVED AT PRESENT.
- GENERAL DEBRIS ON ROOF SHOULD BE REMOVED SUCH AS LARGE ITEMS E.G. LADDERS ETC HAVE BEEN OBSERVED THESE GATHER WATER AND OTHER VEGETATIVE MATER OVER TIME AND HAVE A DETRIMENTAL EFFECT ON THE ROOF.
- A TIMBER ROT AND INFESTATION SURVEY BY A SPECIALIST CONTRACTOR SHOULD BE UNDERTAKEN TO THE TIMBER STRUCTURE BEFORE ANY WORKS ARE CARRIED OUT TO ENSURE COMPLIANCE WITH THE 25YEAR LIFE SPAN OF THE PV PROJECT.

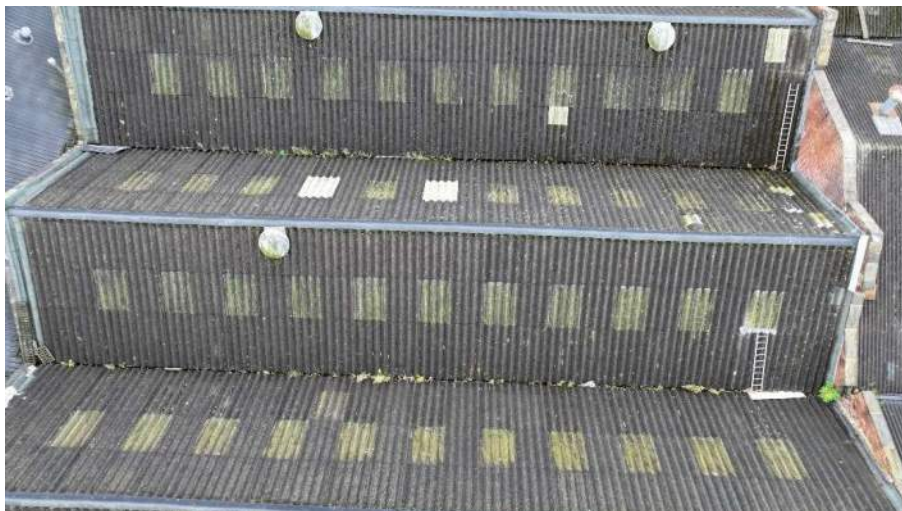
*FIGURE 7: AERIAL PERSPECTIVE OF ROOF 7*

THE MAIN ROOF COVERING APPEARS TO BE IN FAIR CONDITION WITH DEFECTS NOTED AS BELOW:

- FLASHING AGAINST GABLE HAS BEEN PATCHED UP SHOWING PREVIOUS DAMAGE.
- GENERAL STAINING THROUGHOUT THE ROOF AND VEGETATION GROWTH IN TROUGHS OF ROOF SHEETING.
- GRP ROOF LIGHTS HAVE BEEN REPAIRED INDICATING PREVIOUS FAILURE/ DAMAGE EXISTING ROOF LIGHTS MAY REQUIRE REMEDIATION IN THE FUTURE.
- GUTTERS ARE OBSTRUCTED WITH DEBRIS AND VEGETATION.
- WEATHER DEGRADATION HAS BEEN OBSERVED THROUGHOUT.
- ACCESS LADDER ON ROOF.
- PARAPET SHOWS DAMAGE AND LOOSE BRICKS AND MISSING COPESTONES.

- THE FIBRE CEMENT SHEETS ARE TO REMAIN INTACT AND NO INTRUSIVE WORK IS TO BE CARRIED OUT BY PERSONNEL ON SITE OTHER THAN AS SPECIFIED BY MOUNTING DESIGNER. MOUNTING DESIGN SHOULD BE PRESENTED TO STRUCTURAL ENGINEER FOR APPROVAL BEFORE BEING IMPLEMENTED.
- WEATHERED SHEETS ARE PERFORMING ADEQUATELY AND NO SIGNIFICANT DEFECTS IN PERFORMANCE HAVE BEEN FOUND. NO SIGNIFICANT DEFLECTIONS HAVE BEEN NOTED THROUGHOUT ANY OF THE BUILDING ROOF FABRIC.
- VEGETATION GROWTH IS TO BE TREATED AND REMOVED THROUGHOUT AS THIS IS LIKELY TO CAUSE SIGNIFICANT PERFORMANCE ISSUES AND WILL LEAD TO EXPENSIVE REPLACEMENT OF SHEETS IN THE LONG TERM. CLEANING USING A SOFT-BRISTLE BRUSH OR SPONGE, APPLY THE CLEANER TO THE CLADDING SURFACE, WORKING IN SMALL SECTIONS FROM TOP TO BOTTOM. WASHING OF PANELS TO BE UNDERTAKING BY A SPECIALIST ROOF CLEANING COMPANY.

- RAIN WATER GOODS, APEX FLASHINGS AND OTHER METAL FLASHINGS SHOW SIGNS OF DAMAGE. REPLACEMENT OF THESE ARE BEST PRACTICE FOR THE PROLONGED LIFE OF THE ROOF ANY DAMAGED FLASHING MUST BE REPLACED.
- ALL FIXINGS TO SHEETS ETC TO BE FULLY INSPECTED AND REPLACED WHERE ANY DEFECT/CORROSION IS OBSERVED AT THE TIME OF PV INSTALLATION. HOWEVER, NO SIGNIFICANT DEFECT TO FIXINGS HAVE BEEN OBSERVED AT PRESENT.
- GENERAL DEBRIS ON ROOF SHOULD BE REMOVED SUCH AS LARGE ITEMS E.G. LADDERS ETC HAVE BEEN OBSERVED THESE GATHER WATER AND OTHER VEGETATIVE MATER OVER TIME AND HAVE A DETRIMENTAL EFFECT ON THE ROOF.
- REPAIR PARAPET LIKE FOR LIKE.
- A TIMBER ROT AND INFESTATION SURVEY BY A SPECIALIST CONTRACTOR SHOULD BE UNDERTAKEN TO THE TIMBER STRUCTURE BEFORE ANY WORKS ARE CARRIED OUT TO ENSURE COMPLIANCE WITH THE 25YEAR LIFE SPAN OF THE PV PROJECT.

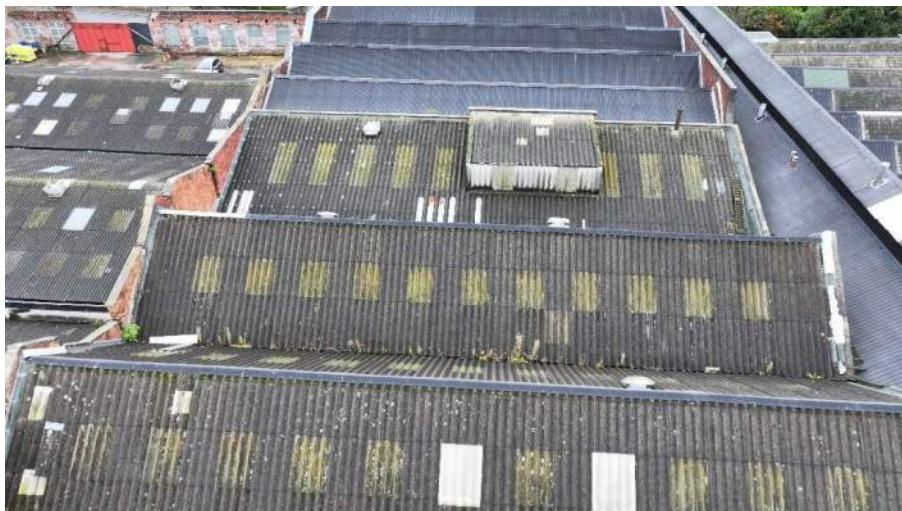
*FIGURE 8: AERIAL PERSPECTIVE OF ROOF 8*

THE MAIN ROOF COVERING APPEARS TO BE IN FAIR CONDITION WITH DEFECTS NOTED AS BELOW:

- FLASHING AGAINST GABLE HAS BEEN PATCHED UP SHOWING PREVIOUS DAMAGE.
- GENERAL STAINING THROUGHOUT THE ROOF AND VEGETATION GROWTH IN TROUGHS OF ROOF SHEETING.
- GRP ROOF LIGHTS HAVE BEEN REPAIRED INDICATING PREVIOUS FAILURE/ DAMAGE EXISTING ROOF LIGHTS MAY REQUIRE REMEDIATION IN THE FUTURE.
- GUTTERS ARE OBSTRUCTED WITH DEBRIS AND VEGETATION.
- WEATHER DEGRADATION HAS BEEN OBSERVED THROUGHOUT.
- PARAPET SHOWS DAMAGE AND LOOSE BRICKS AND MISSING COPESTONES.

- WEATHERED SHEETS ARE PERFORMING ADEQUATELY AND NO SIGNIFICANT DEFECTS IN PERFORMANCE HAVE BEEN FOUND. NO SIGNIFICANT DEFLECTIONS HAVE BEEN NOTED THROUGHOUT ANY OF THE BUILDING ROOF FABRIC.

- VEGETATION GROWTH IS TO BE TREATED AND REMOVED THROUGHOUT AS THIS IS LIKELY TO CAUSE SIGNIFICANT PERFORMANCE ISSUES AND WILL LEAD TO EXPENSIVE REPLACEMENT OF SHEETS IN THE LONG TERM. CLEANING USING A SOFT-BRISTLE BRUSH OR SPONGE, APPLY THE CLEANER TO THE CLADDING SURFACE, WORKING IN SMALL SECTIONS FROM TOP TO BOTTOM. WASHING OF PANELS TO BE UNDERTAKING BY A SPECIALIST ROOF CLEANING COMPANY.

- RAIN WATER GOODS, APEX FLASHINGS AND OTHER METAL FLASHINGS SHOW SIGNS OF DAMAGE. REPLACEMENT OF THESE ARE BEST PRACTICE FOR THE PROLONGED LIFE OF THE ROOF ANY DAMAGED FLASHING MUST BE REPLACED.

- ALL FIXINGS TO SHEETS ETC TO BE FULLY INSPECTED AND REPLACED WHERE ANY DEFECT/CORROSION IS OBSERVED AT THE TIME OF PV INSTALLATION. HOWEVER, NO SIGNIFICANT DEFECT TO FIXINGS HAVE BEEN OBSERVED AT PRESENT.
- REPAIR PARAPET LIKE FOR LIKE.
- A TIMBER ROT AND INFESTATION SURVEY BY A SPECIALIST CONTRACTOR SHOULD BE UNDERTAKEN TO THE TIMBER STRUCTURE BEFORE ANY WORKS ARE CARRIED OUT TO ENSURE COMPLIANCE WITH THE 25YEAR LIFE SPAN OF THE PV PROJECT.

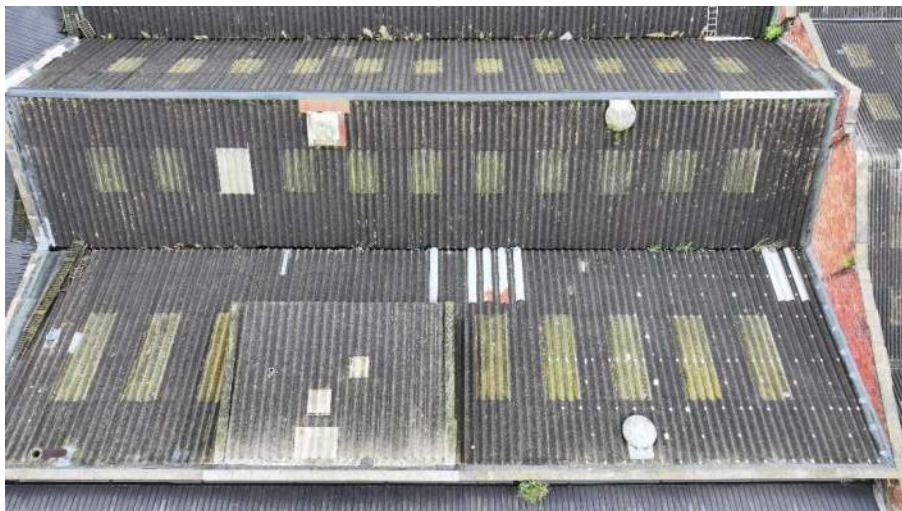
*FIGURE 9: AERIAL PERSPECTIVE OF ROOF 9*

THE MAIN ROOF COVERING APPEARS TO BE IN FAIR CONDITION WITH DEFECTS NOTED AS BELOW:

- FLASHING AGAINST GABLE HAS BEEN PATCHED UP SHOWING PREVIOUS DAMAGE.
- GENERAL STAINING THROUGHOUT THE ROOF AND VEGETATION GROWTH IN TROUGHS OF ROOF SHEETING.
- GRP ROOF LIGHTS HAVE BEEN REPAIRED INDICATING PREVIOUS FAILURE/ DAMAGE EXISTING ROOF LIGHTS MAY REQUIRE REMEDIATION IN THE FUTURE.
- GUTTERS ARE OBSTRUCTED WITH DEBRIS AND VEGETATION.
- WEATHER DEGRADATION HAS BEEN OBSERVED THROUGHOUT.
- GENERAL LARGE DEBRIS ON ROOF.
- PARAPET SHOWS VEGETATION AND SHOULD BE TREATED BEFORE FURTHER GROWTH THAT CAN DAMAGE THE BRICK WORK.
- HOLE IN ROOF HAS BEEN OBSERVED WHICH IS POSSIBLY FROM A PREVIOUS CHIMNEY OF SIMILAR PIPE STRUCTURE PENETRATION.

- THE FIBRE CEMENT SHEETS ARE TO REMAIN INTACT AND NO INTRUSIVE WORK IS TO BE CARRIED OUT BY PERSONNEL ON SITE OTHER THAN AS SPECIFIED BY MOUNTING DESIGNER. MOUNTING DESIGN SHOULD BE PRESENTED TO STRUCTURAL ENGINEER FOR APPROVAL BEFORE BEING IMPLEMENTED.
- WEATHERED SHEETS ARE PERFORMING ADEQUATELY AND NO SIGNIFICANT DEFECTS IN PERFORMANCE HAVE BEEN FOUND. NO SIGNIFICANT DEFLECTIONS HAVE BEEN NOTED THROUGHOUT ANY OF THE BUILDING ROOF FABRIC.
- VEGETATION GROWTH IS TO BE TREATED AND REMOVED THROUGHOUT AS THIS IS LIKELY TO CAUSE SIGNIFICANT PERFORMANCE ISSUES AND WILL LEAD TO EXPENSIVE REPLACEMENT OF SHEETS IN THE LONG TERM. CLEANING USING A SOFT-BRISTLE BRUSH OR SPONGE, APPLY THE CLEANER TO THE CLADDING SURFACE, WORKING IN SMALL

- RAIN WATER GOODS, APEX FLASHINGS AND OTHER METAL FLASHINGS SHOW SIGNS OF DAMAGE. REPLACEMENT OF THESE ARE BEST PRACTICE FOR THE PROLONGED LIFE OF THE ROOF ANY DAMAGED FLASHING MUST BE REPLACED.
- ALL FIXINGS TO SHEETS ETC TO BE FULLY INSPECTED AND REPLACED WHERE ANY DEFECT/CORROSION IS OBSERVED AT THE TIME OF PV INSTALLATION. HOWEVER, NO SIGNIFICANT DEFECT TO FIXINGS HAVE BEEN OBSERVED AT PRESENT.
- GENERAL DEBRIS ON ROOF SHOULD BE REMOVED SUCH AS LARGE ITEMS E.G. PLANKS ETC HAVE BEEN OBSERVED THESE GATHER WATER AND OTHER VEGETATIVE MATER OVER TIME AND HAVE A DETRIMENTAL EFFECT ON THE ROOF.
- REMOVE VEGETATION FROM PARAPET.
- REPAIR ROOF WHERE HOLE IS
- A TIMBER ROT AND INFESTATION SURVEY BY A SPECIALIST CONTRACTOR SHOULD BE UNDERTAKEN TO THE TIMBER STRUCTURE BEFORE ANY WORKS ARE CARRIED OUT TO ENSURE COMPLIANCE WITH THE 25YEAR LIFE SPAN OF THE PV PROJECT.

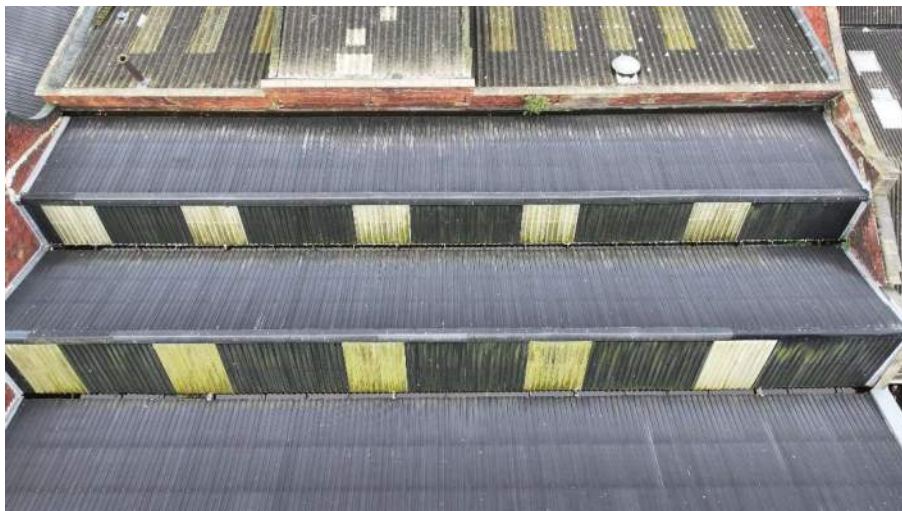
*FIGURE 10: AERIAL PERSPECTIVE OF ROOF 10*

THE MAIN ROOF COVERING APPEARS TO BE IN GOOD CONDITION.

- WEATHERING IS OBSERVED THROUGHOUT.
- IT IS TO BE NOTED THAT FIXINGS ARE TO BE INSPECTED FOR ANY CORRODED/BROKEN AND TO BE REPLACED.
- GUTTERS CONTAIN VEGETATION/DEBRIS.
- NO FURTHER DEFECTS ARE NOTED. HENCE, MINIMAL REMEDIATION REQUIRED.
- GRP LIGHTS SEEM TO BE IN GOOD CONDITION.
- PARAPET HAS A LARGE SECTION OF MISSING MASONRY.

- THE MAIN ROOF COVERING REQUIRES TO BE PRESSURE WASHED, ANY LOOSE PAINT AND CORROSION TO BE REMOVED, GUN APPLIED MASTIC AT ANY UNSEALED AREAS. AN EXTERNAL WEATHERPROOF AND CORROSION RESISTANT COATING SUCH AS FOSROC GALVAFROID TO BE APPLIED THROUGHOUT TO PREVENT FUTURE DEFECTS.
- ANY CORRODED/BROKEN FIXINGS TO BE REPLACED FOR LIKE TO LIKE. ALL GUTTERS TO BE CLEANED AND ANY OBSTRUCTIONS TO BE REMOVED, WHERE THE GUTTERS ARE DEFORMED THESE ARE TO BE REPAIRED SO THAT NO FLOW IS RESTRICTED THROUGHOUT.
- PARAPET MASONRY TO BE REPLACED LIKE FOR LIKE.
- A TIMBER ROT AND INFESTATION SURVEY BY A SPECIALIST CONTRACTOR SHOULD BE UNDERTAKEN TO THE TIMBER STRUCTURE BEFORE ANY WORKS ARE CARRIED OUT TO ENSURE COMPLIANCE WITH THE 25YEAR LIFE SPAN OF THE PV PROJECT.

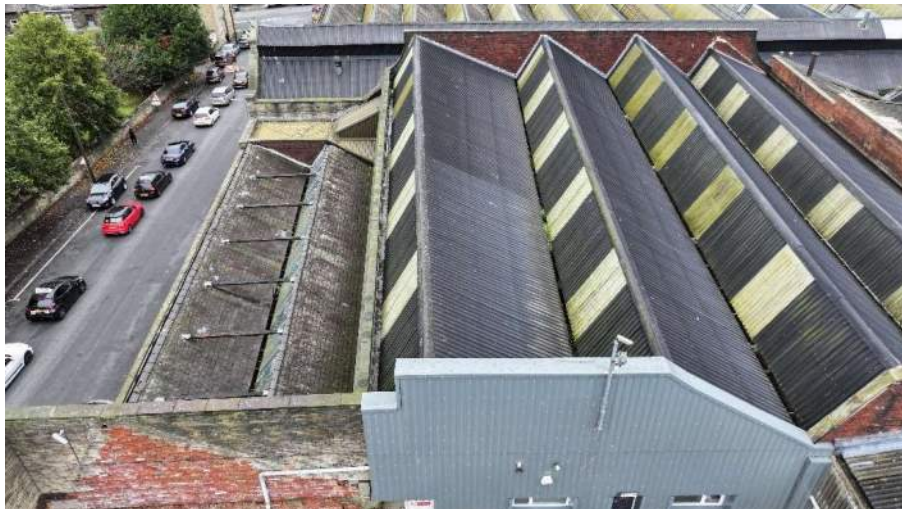
*FIGURE 11: AERIAL PERSPECTIVE OF ROOF 11*

THE MAIN ROOF COVERING APPEARS TO BE IN GOOD CONDITION.

- WEATHERING IS OBSERVED THROUGHOUT.
- IT IS TO BE NOTED THAT FIXINGS ARE TO BE INSPECTED FOR ANY CORRODED/BROKEN AND TO BE REPLACED.
- GUTTERS CONTAIN VEGETATION/DEBRIS.
- NO FURTHER DEFECTS ARE NOTED. HENCE, MINIMAL REMEDIATION REQUIRED.
- GRP LIGHTS SEEM TO BE IN GOOD CONDITION.
- PARAPET HAS A LARGE SECTION OF MISSING MASONRY.

- THE MAIN ROOF COVERING REQUIRES TO BE PRESSURE WASHED, ANY LOOSE PAINT AND CORROSION TO BE REMOVED, GUN APPLIED MASTIC AT ANY UNSEALED AREAS. AN EXTERNAL WEATHERPROOF AND CORROSION RESISTANT COATING SUCH AS FOSROC GALVAFROID TO BE APPLIED THROUGHOUT TO PREVENT FUTURE DEFECTS.
- ANY CORRODED/BROKEN FIXINGS TO BE REPLACED FOR LIKE TO LIKE. ALL GUTTERS TO BE CLEANED AND ANY OBSTRUCTIONS TO BE REMOVED, WHERE THE GUTTERS ARE DEFORMED THESE ARE TO BE REPAIRED SO THAT NO FLOW IS RESTRICTED THROUGHOUT.
- PARAPET MASONRY TO BE REPLACED LIKE FOR LIKE.
- A TIMBER ROT AND INFESTATION SURVEY BY A SPECIALIST CONTRACTOR SHOULD BE UNDERTAKEN TO THE TIMBER STRUCTURE BEFORE ANY WORKS ARE CARRIED OUT TO ENSURE COMPLIANCE WITH THE 25YEAR LIFE SPAN OF THE PV PROJECT.

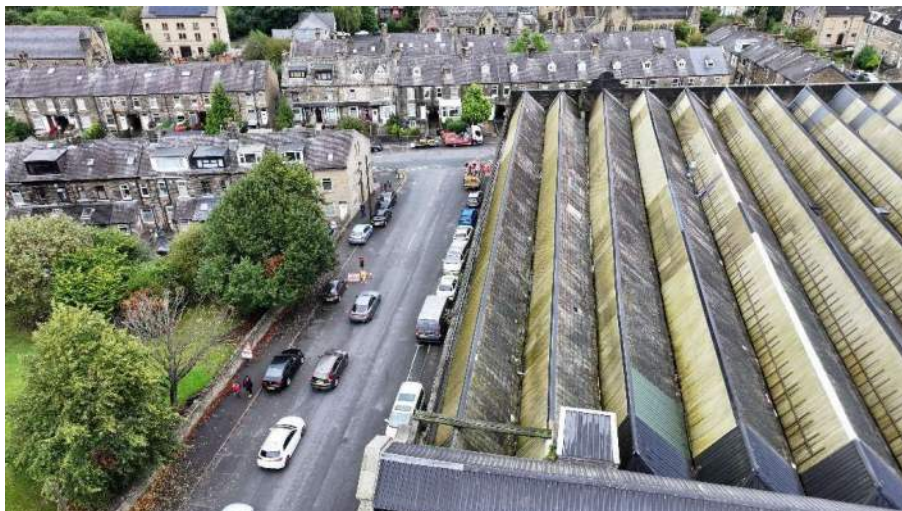
*FIGURE 12: AERIAL PERSPECTIVE OF ROOF 12*

THE MAIN ROOF COVERING APPEARS TO BE IN FAIR CONDITION WITH DEFECTS NOTED AS BELOW:

- DEBRIS SUCH AS WOODEN PLANK ON THE ROOF.
- VALLEY GUTTERS ARE OBSTRUCTED WITH DEBRIS AND VEGETATION.
- WEATHER DEGRADATION HAS BEEN OBSERVED THROUGHOUT.
- PARAPET HAS DEGRADED AND MISSING POINTING.
- TILES ARE BROKEN AND SLIPPED CLOSE TO THE VALLEY

NOTE: WATER STAINING HAS BEEN NOTED BELOW IN THE SUSPENDED CEILING WHICH MAY INDICATE WATER INGRESS. THIS MAY BE ONGOING BUT LOOKS HISTORIC IN NATURE.

- A TIMBER ROT AND INFESTATION SURVEY BY A SPECIALIST CONTRACTOR SHOULD BE UNDERTAKEN TO THE TIMBER STRUCTURE BEFORE ANY WORKS ARE CARRIED OUT TO ENSURE COMPLIANCE WITH THE 25YEAR LIFE SPAN OF THE PV PROJECT.

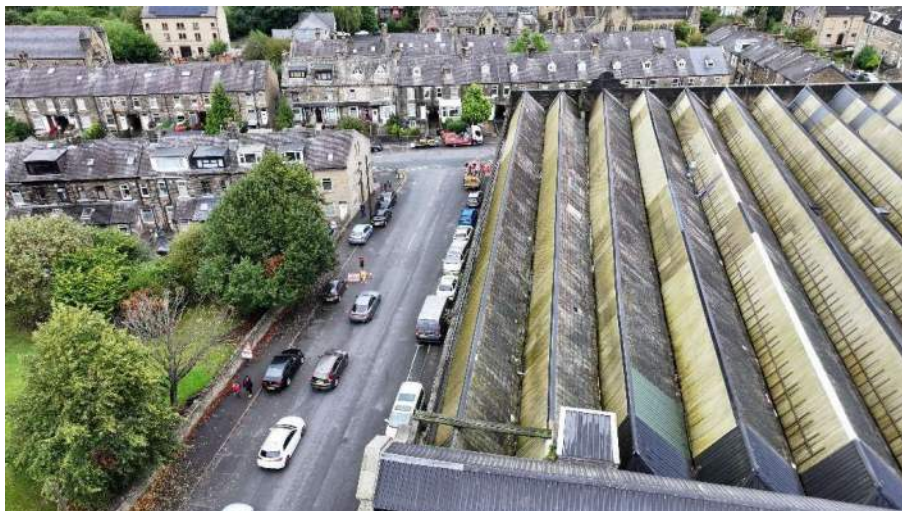
*FIGURE 13: AERIAL PERSPECTIVE OF ROOF 13*

THE MAIN ROOF COVERING APPEARS TO BE IN FAIR CONDITION WITH DEFECTS NOTED AS BELOW:

- A TIMBER ROT AND INFESTATION SURVEY BY A SPECIALIST CONTRACTOR SHOULD BE UNDERTAKEN TO THE TIMBER STRUCTURE BEFORE ANY WORKS ARE CARRIED OUT TO ENSURE COMPLIANCE WITH THE 25YEAR LIFE SPAN OF THE PV PROJECT.

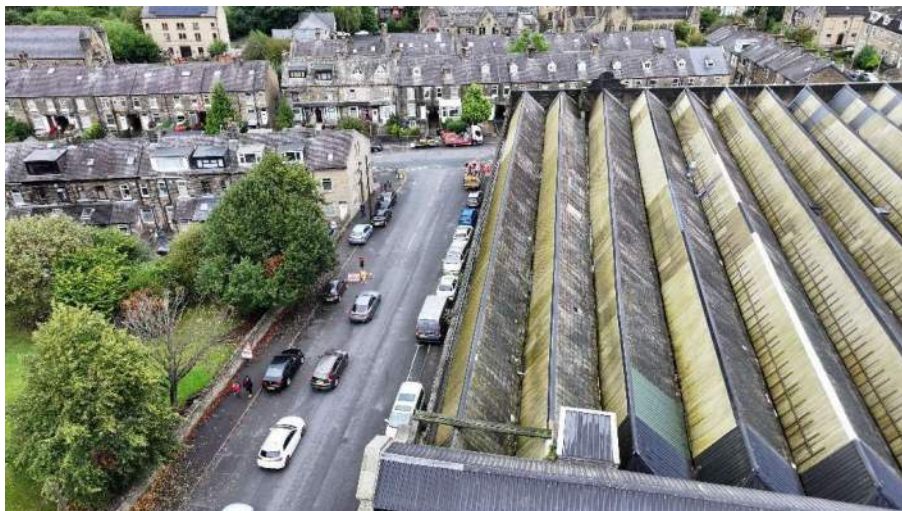
*FIGURE 14: AERIAL PERSPECTIVE OF ROOF 14*

THE MAIN ROOF COVERING APPEARS TO BE IN FAIR CONDITION WITH DEFECTS NOTED AS BELOW:

- A TIMBER ROT AND INFESTATION SURVEY BY A SPECIALIST CONTRACTOR SHOULD BE UNDERTAKEN TO THE TIMBER STRUCTURE BEFORE ANY WORKS ARE CARRIED OUT TO ENSURE COMPLIANCE WITH THE 25YEAR LIFE SPAN OF THE PV PROJECT.
