A FIELD DATASET REPORT

# The UK Roof *Plane Report.*

*1,568 roof planes on 651 buildings and homes assessed for rooftop solar PV, 1 January to 19 September 2026: what is on the roof, how it is built, and what condition it is in.*

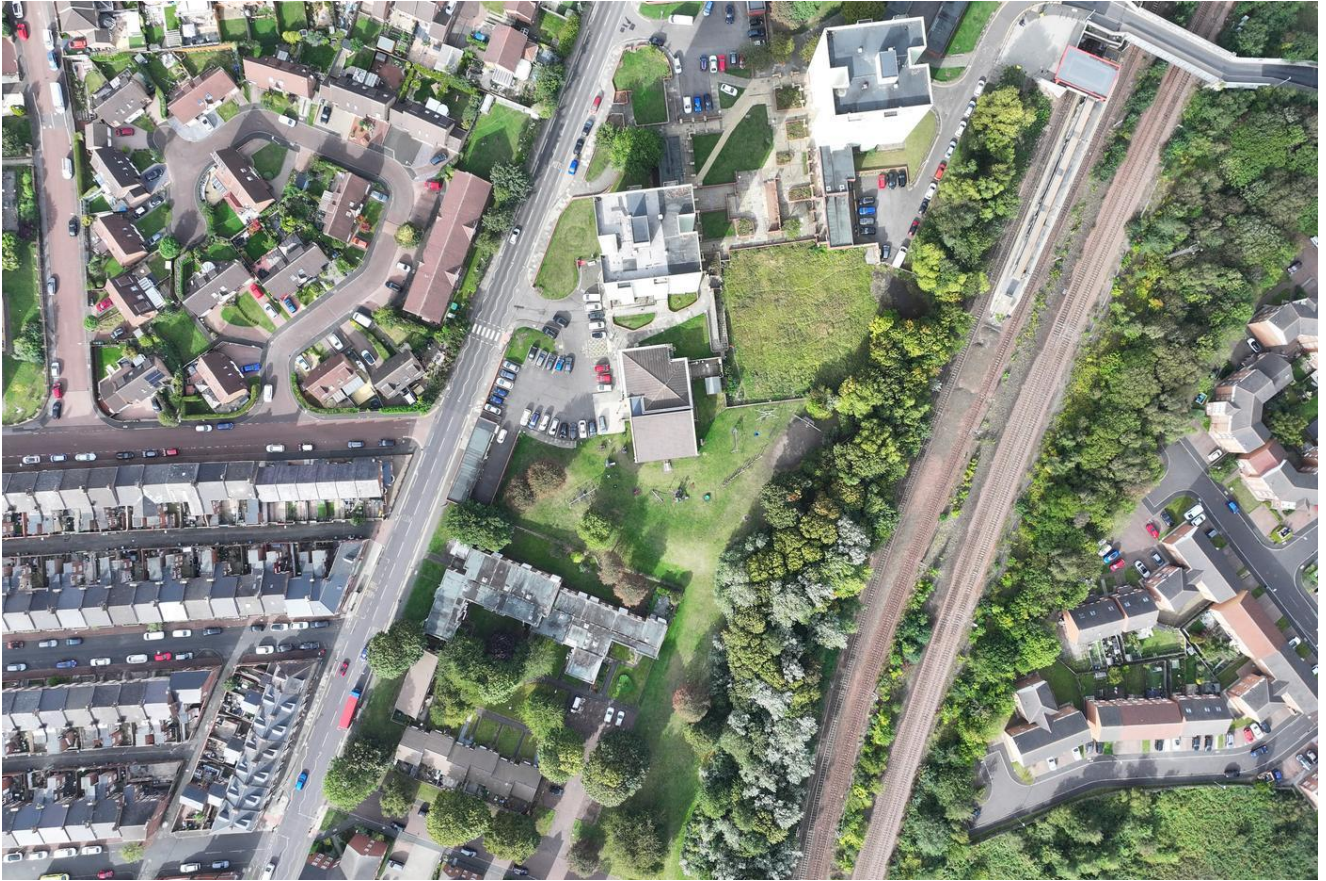
Mixed terraced and post-war housing, photographed by drone on survey. Residential records are dominated by programmes of this kind.

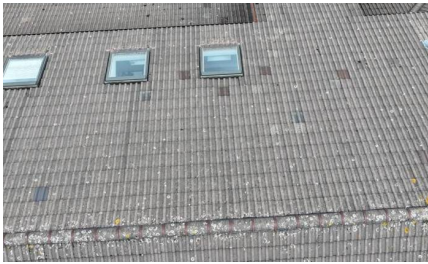
CONCRETE PLAIN TILE

42 of 145 commercial buildings (29%) carried two or more distinct coverings, and 71 (49%) more than one roof form. The combinations are characteristic of the building types: schools pairing pitched slate or tile ranges with felt flat roofs over later extensions; industrial estates pairing profiled metal with older fibre cement ranges; community buildings pairing concrete tile with felt.

For the design of a PV installation, each covering is a different fixing, a different self-weight and a different access regime. A building-level record that names one covering, typically the dominant one, loses the variation that most often changes the design.

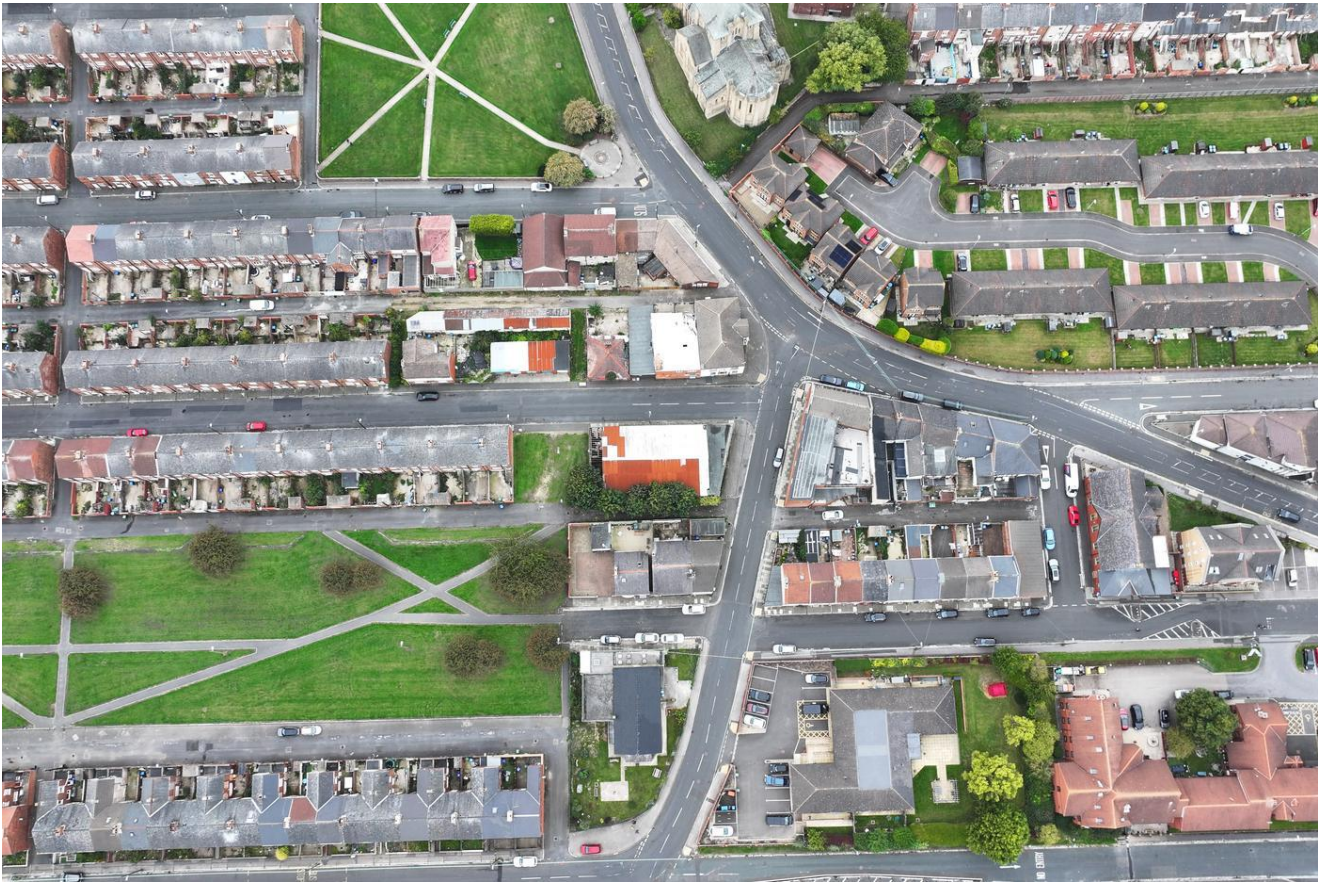
Colliery-era terraced streets. Repetition makes programme-scale assessment efficient; local variation in covering and altitude is why it still has to be done house type by house type, and area by area.

Programmes are assessed by house type, and a type and its variant, for example the same house with a larger rear projection, are separate records. A change in plan changes the roof: its span, its hips and valleys, and the planes available for an array.
