**TITLE: ROOF CONDITION REPORT**

THE SCOPE OF THE SERVICES PERTAINED IN THIS DOCUMENT IS A DETAILED ASSESSMENT FOR THE ROOF CONDITION OF THE INDUSTRIAL BUILDING WITHIN THE SITE BOUNDARY TO ASCERTAIN SUITABILITY IN RELATION OF INSTALLATION OF PV PANELS.

THIS REPORT CONTAINS COMMENTARY AND HIGHLIGHTS ON ANY DEFECTS INSPECTED VISUALLY VIA DRONE. A DRONE SURVEY FOR THE SITE HAS BEEN CARRIED OUT AND A FULL SITE AERIAL RECONNAISSANCE HAS TAKEN PLACE WHICH FORMS THE BASIS OF THIS REPORT.

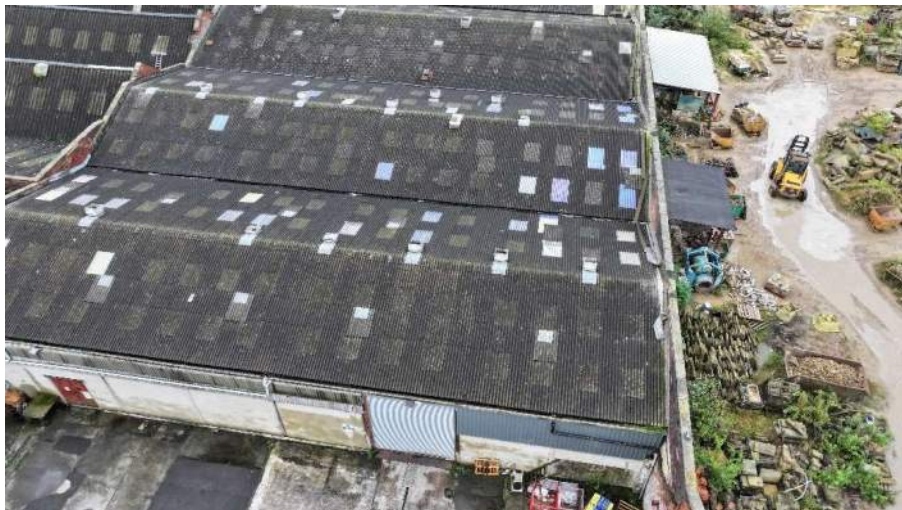
*FIGURE 1: AERIAL PERSPECTIVE OF ROOF 1*

THE MAIN ROOF COVERING APPEARS TO BE IN FAIR CONDITION WITH DEFECTS NOTED AS BELOW:

- APEX FLASHING AGAINST GABLE IS DAMAGED AND LOOSE ON ROOF.
- GENERAL STAINING THROUGHOUT THE ROOF AND VEGETATION GROWTH IN TROUGHS OF ROOF SHEETING.
- GRP ROOF LIGHTS HAVE BEEN REPAIRED INDICATING PREVIOUS FAILURE/ DAMAGE EXISTING ROOF LIGHTS MAY REQUIRE REMEDIATION IN THE FUTURE.
- GUTTERS ARE OBSTRUCTED WITH DEBRIS AND VEGETATION.
- WEATHER DEGRADATION HAS BEEN OBSERVED THROUGHOUT.
- GENERAL DEBRIS ON ROOF INCLUDING WOODEN PLANKS ETC.

- THE FIBRE CEMENT SHEETS ARE TO REMAIN INTACT AND NO INTRUSIVE WORK IS TO BE CARRIED OUT BY PERSONNEL ON SITE OTHER THAN AS SPECIFIED BY MOUNTING DESIGNER. MOUNTING DESIGN SHOULD BE PRESENTED TO STRUCTURAL ENGINEER FOR APPROVAL BEFORE BEING IMPLEMENTED.
- WEATHERED SHEETS ARE PERFORMING ADEQUATELY AND NO SIGNIFICANT DEFECTS IN PERFORMANCE HAVE BEEN FOUND. NO SIGNIFICANT DEFLECTIONS HAVE BEEN NOTED THROUGHOUT ANY OF THE BUILDING ROOF FABRIC.
- VEGETATION GROWTH IS TO BE TREATED AND REMOVED THROUGHOUT AS THIS IS LIKELY TO CAUSE SIGNIFICANT PERFORMANCE ISSUES AND WILL LEAD TO EXPENSIVE REPLACEMENT OF SHEETS IN THE LONG TERM. CLEANING USING A SOFT-BRISTLE BRUSH OR SPONGE, APPLY THE CLEANER TO THE CLADDING SURFACE, WORKING IN SMALL SECTIONS FROM TOP TO BOTTOM. WASHING OF PANELS TO BE UNDERTAKING BY A SPECIALIST ROOF CLEANING COMPANY.

- RAIN WATER GOODS, APEX FLASHINGS AND OTHER METAL FLASHINGS SHOW SIGNS OF DAMAGE. REPLACEMENT OF THESE ARE BEST PRACTICE FOR THE PROLONGED LIFE OF THE ROOF ANY DAMAGED FLASHING MUST BE REPLACED.
- ALL FIXINGS TO SHEETS ETC TO BE FULLY INSPECTED AND REPLACED WHERE ANY DEFECT/CORROSION IS OBSERVED AT THE TIME OF PV INSTALLATION. HOWEVER, NO SIGNIFICANT DEFECT TO FIXINGS HAVE BEEN OBSERVED AT PRESENT.
- GENERAL DEBRIS ON ROOF SHOULD BE REMOVED SUCH AS LARGE ITEMS E.G. PLANKS ETC HAVE BEEN OBSERVED THESE GATHER WATER AND OTHER VEGETATIVE MATER OVER TIME AND HAVE A DETRIMENTAL EFFECT ON THE ROOF.

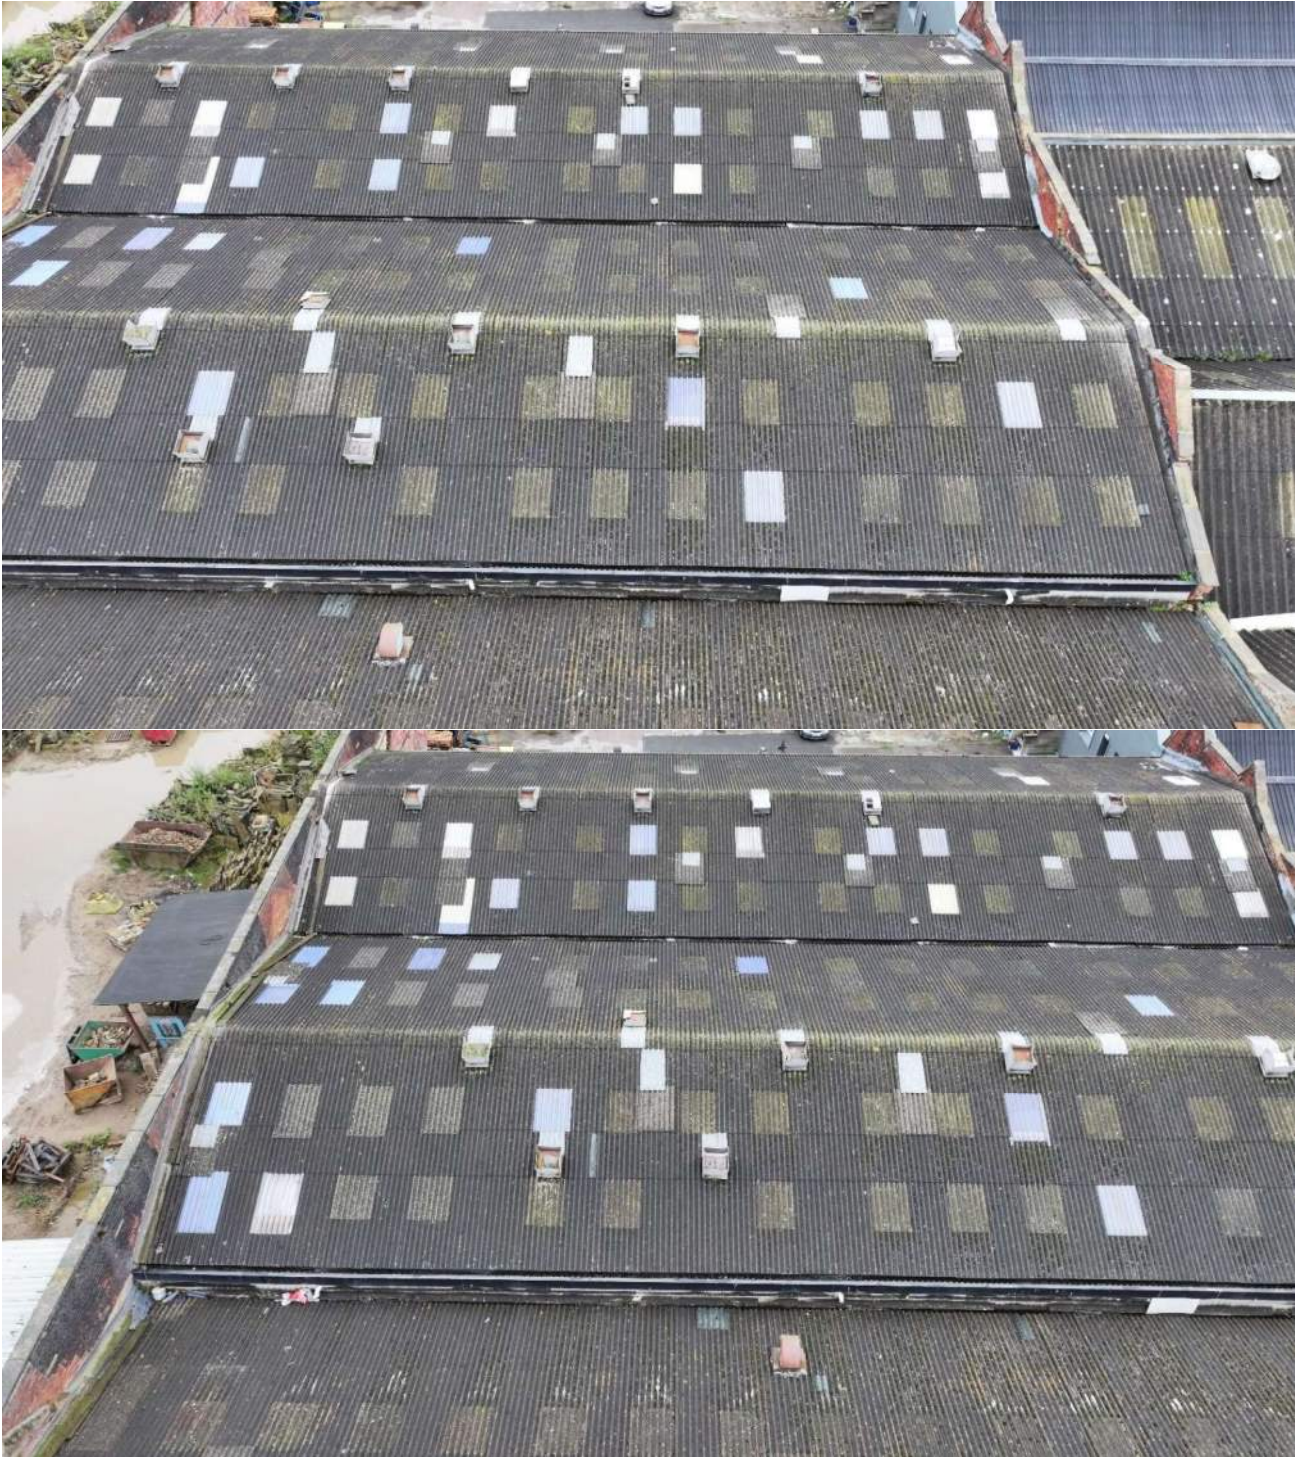
APPENDIX B: ROOF 2 PHOTOGRAPHS

- FLASHING AGAINST GABLE IS DAMAGED AND LOOSE ON ROOF.
- GENERAL STAINING THROUGHOUT THE ROOF AND VEGETATION GROWTH IN TROUGHS OF ROOF SHEETING.
- GRP ROOF LIGHTS HAVE BEEN REPAIRED INDICATING PREVIOUS FAILURE/ DAMAGE EXISTING ROOF LIGHTS MAY REQUIRE REMEDIATION IN THE FUTURE.
- GUTTERS ARE OBSTRUCTED WITH DEBRIS AND VEGETATION.
- WEATHER DEGRADATION HAS BEEN OBSERVED THROUGHOUT.
- LOOSE/ MISSING BRICKS ARE FOUND AT THE BRICK WORK TO THE GABLE PARAPET.
- GENERAL DEBRIS ON ROOF INCLUDING WOODEN PLANKS ETC.

- RAIN WATER GOODS, APEX FLASHINGS AND OTHER METAL FLASHINGS SHOW SIGNS OF DAMAGE. REPLACEMENT OF THESE ARE BEST PRACTICE FOR THE PROLONGED LIFE OF THE ROOF ANY DAMAGED FLASHING MUST BE REPLACED.
- ALL FIXINGS TO SHEETS ETC TO BE FULLY INSPECTED AND REPLACED WHERE ANY DEFECT/CORROSION IS OBSERVED AT THE TIME OF PV INSTALLATION. HOWEVER, NO SIGNIFICANT DEFECT TO FIXINGS HAVE BEEN OBSERVED AT PRESENT.
- GENERAL DEBRIS ON ROOF SHOULD BE REMOVED SUCH AS LARGE ITEMS E.G. PLANKS ETC HAVE BEEN OBSERVED THESE GATHER WATER AND OTHER VEGETATIVE MATER OVER TIME AND HAVE A DETRIMENTAL EFFECT ON THE ROOF.
- LOOSE/ MISSING BRICKS SHOULD BE REPLACED LIKE FOR LIKE.

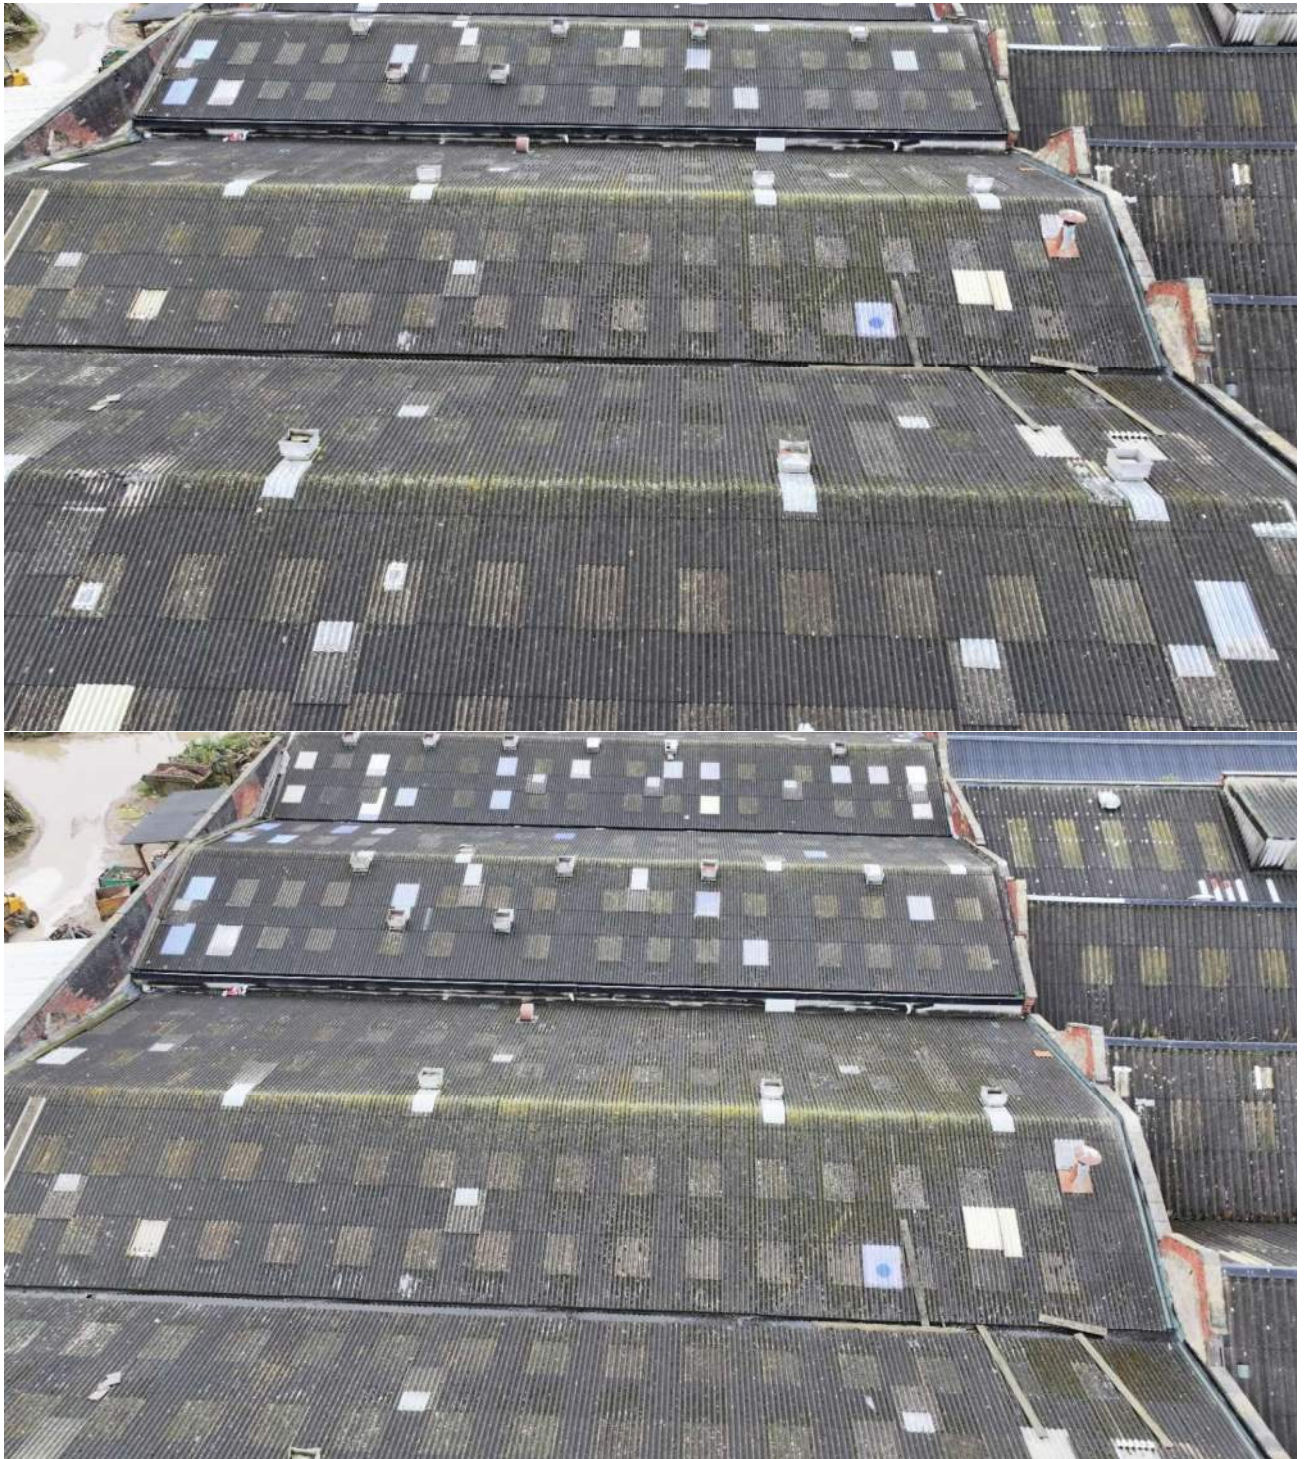
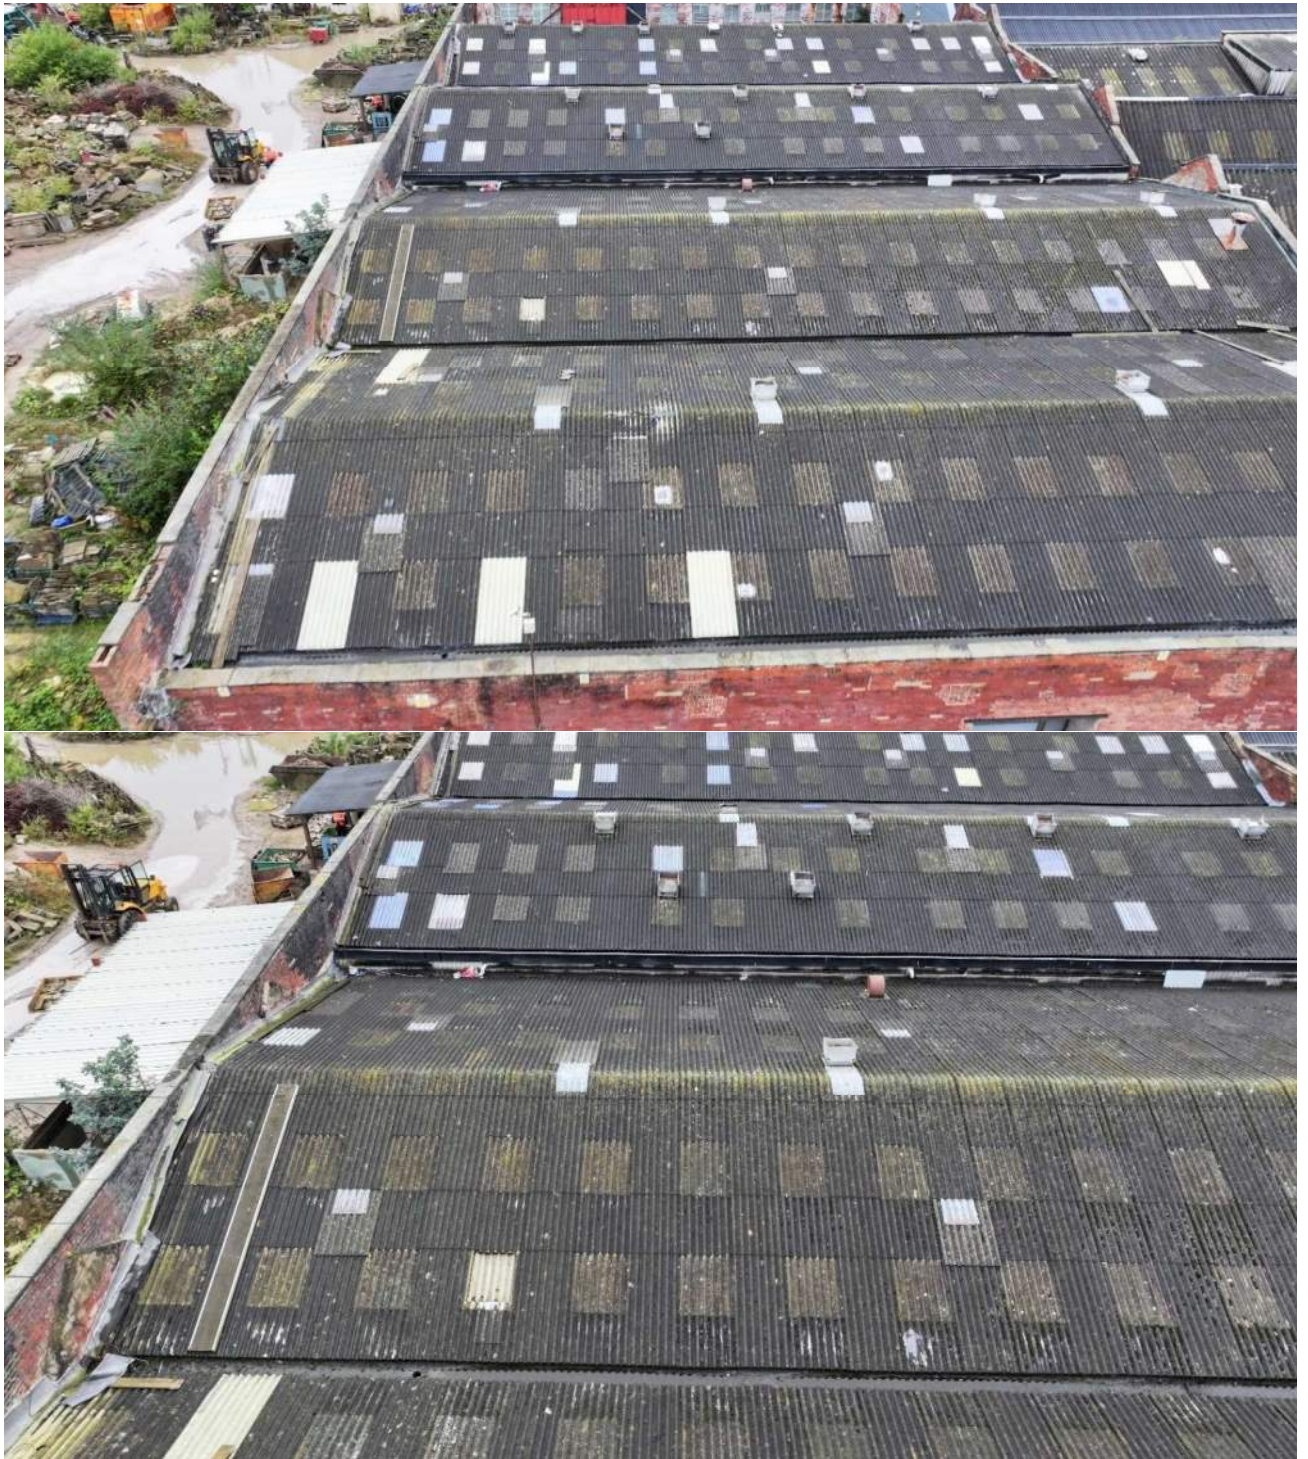
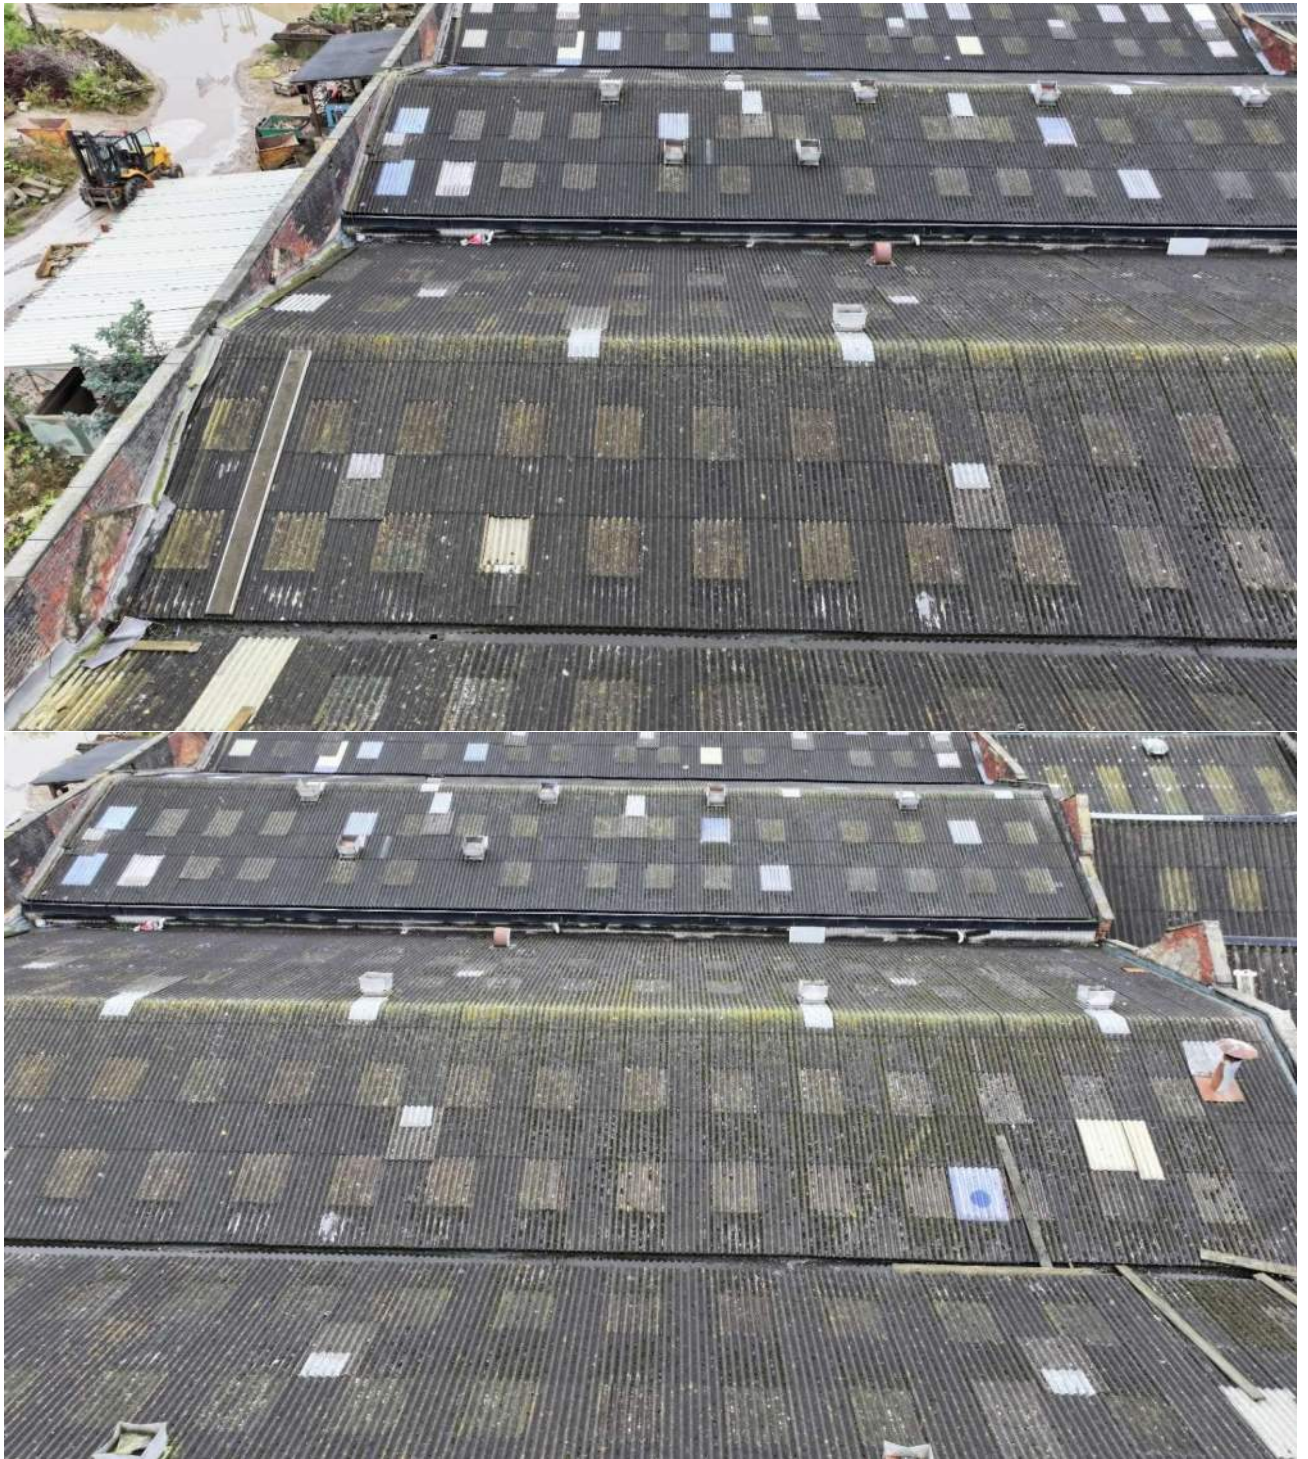
APPENDIX C: ROOF 3 PHOTOGRAPHS

- FLASHING AGAINST GABLE IS DAMAGED AND LOOSE ON ROOF.
- GENERAL STAINING THROUGHOUT THE ROOF AND VEGETATION GROWTH IN TROUGHS OF ROOF SHEETING.
- GRP ROOF LIGHTS HAVE BEEN REPAIRED INDICATING PREVIOUS FAILURE/ DAMAGE EXISTING ROOF LIGHTS MAY REQUIRE REMEDIATION IN THE FUTURE.
- GUTTERS ARE OBSTRUCTED WITH DEBRIS AND VEGETATION.
- WEATHER DEGRADATION HAS BEEN OBSERVED THROUGHOUT.
- LOOSE/ MISSING BRICKS ARE FOUND AT THE BRICK WORK TO THE GABLE PARAPET.
- GENERAL DEBRIS ON ROOF INCLUDING WOODEN PLANKS ETC.
- CHIMNEY SHOWS SIGNS OF CORROSION WHICH MAY LEAD TO FURTHER DETERIORATION.

- THE FIBRE CEMENT SHEETS ARE TO REMAIN INTACT AND NO INTRUSIVE WORK IS TO BE CARRIED OUT BY PERSONNEL ON SITE OTHER THAN AS SPECIFIED BY MOUNTING DESIGNER. MOUNTING DESIGN SHOULD BE PRESENTED TO STRUCTURAL ENGINEER FOR APPROVAL BEFORE BEING IMPLEMENTED.
- WEATHERED SHEETS ARE PERFORMING ADEQUATELY AND NO SIGNIFICANT DEFECTS IN PERFORMANCE HAVE BEEN FOUND. NO SIGNIFICANT DEFLECTIONS HAVE BEEN NOTED THROUGHOUT ANY OF THE BUILDING ROOF FABRIC.
- VEGETATION GROWTH IS TO BE TREATED AND REMOVED THROUGHOUT AS THIS IS LIKELY TO CAUSE SIGNIFICANT PERFORMANCE ISSUES AND WILL LEAD TO EXPENSIVE REPLACEMENT OF SHEETS IN THE LONG TERM. CLEANING USING A SOFT-BRISTLE BRUSH OR SPONGE, APPLY THE CLEANER TO THE CLADDING SURFACE, WORKING IN SMALL SECTIONS FROM TOP TO BOTTOM. WASHING OF PANELS TO BE UNDERTAKING BY A SPECIALIST ROOF CLEANING COMPANY.
